ARG SURVEYS LTD

24 Leopold Road, London, SW19 7BD

Management Survey

8 Jan 2016

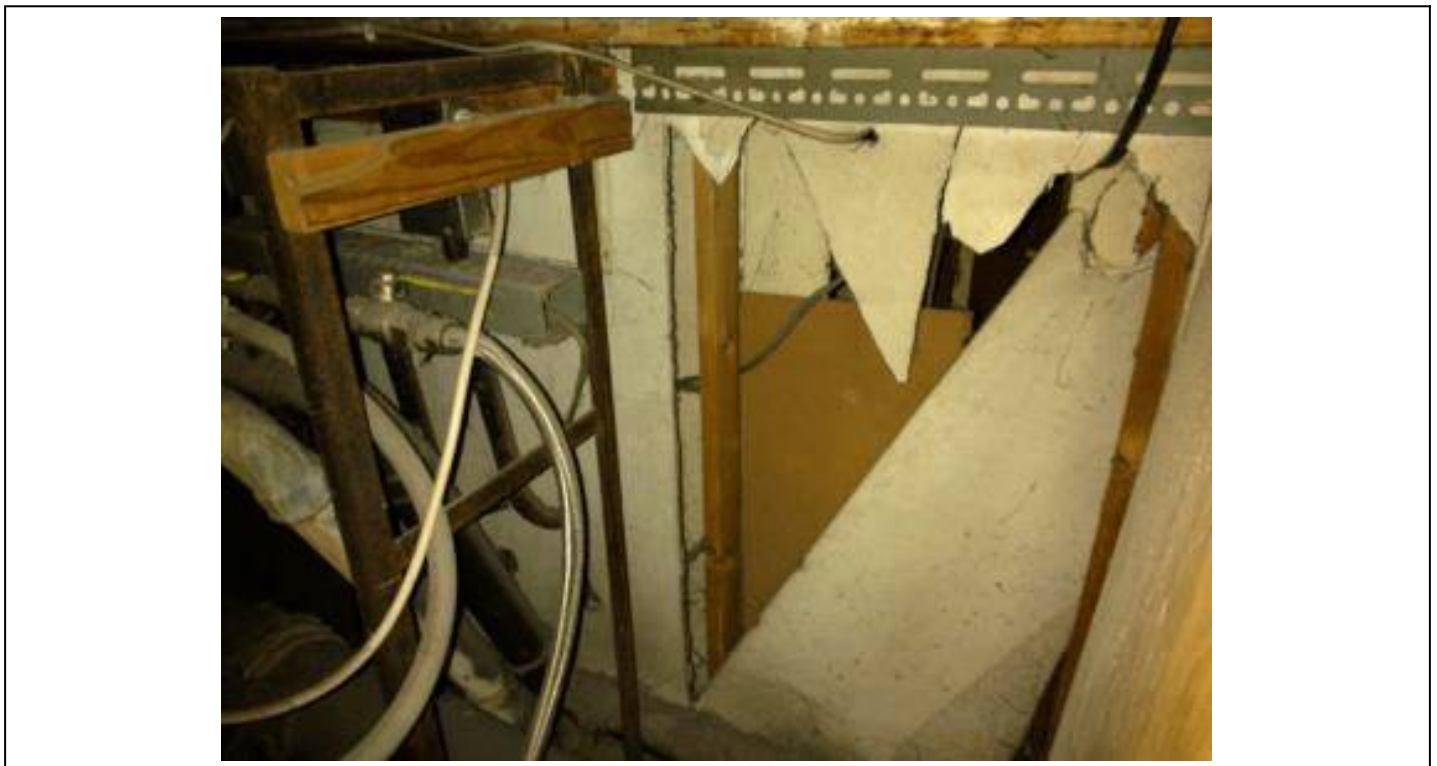
Item Number:	1 Ref Item: N/A	Sample Reference	AB000196
Item Description:	Wall panels	Approx. Quantity:	32m ²
Position:	Insulating board to walls behind laundry machinery & timber cladding.	Identification:	Identified
Item Material:	Asbestos Insulating Board	Asbestos Present:	Amosite

MATERIAL ASSESSMENT (MA)		PRIORITY ASSESSMENT (PA)	
Product Type:	2	Maintenance Activity:	0
Damage:	2	Occupant Activity:	1
Treatment:	2	Likelihood of Disturbance:	2
Asbestos Type:	2	Human Exposure Potential:	3
MA Score:	8	PA Score:	6

Total Assessment:	14	Medium
Comments:	Removed damage board and encapsulate. 14m2 Visible. .	
Recommendation:	Remove under Fully Controlled Conditions	Timescale 6 Months

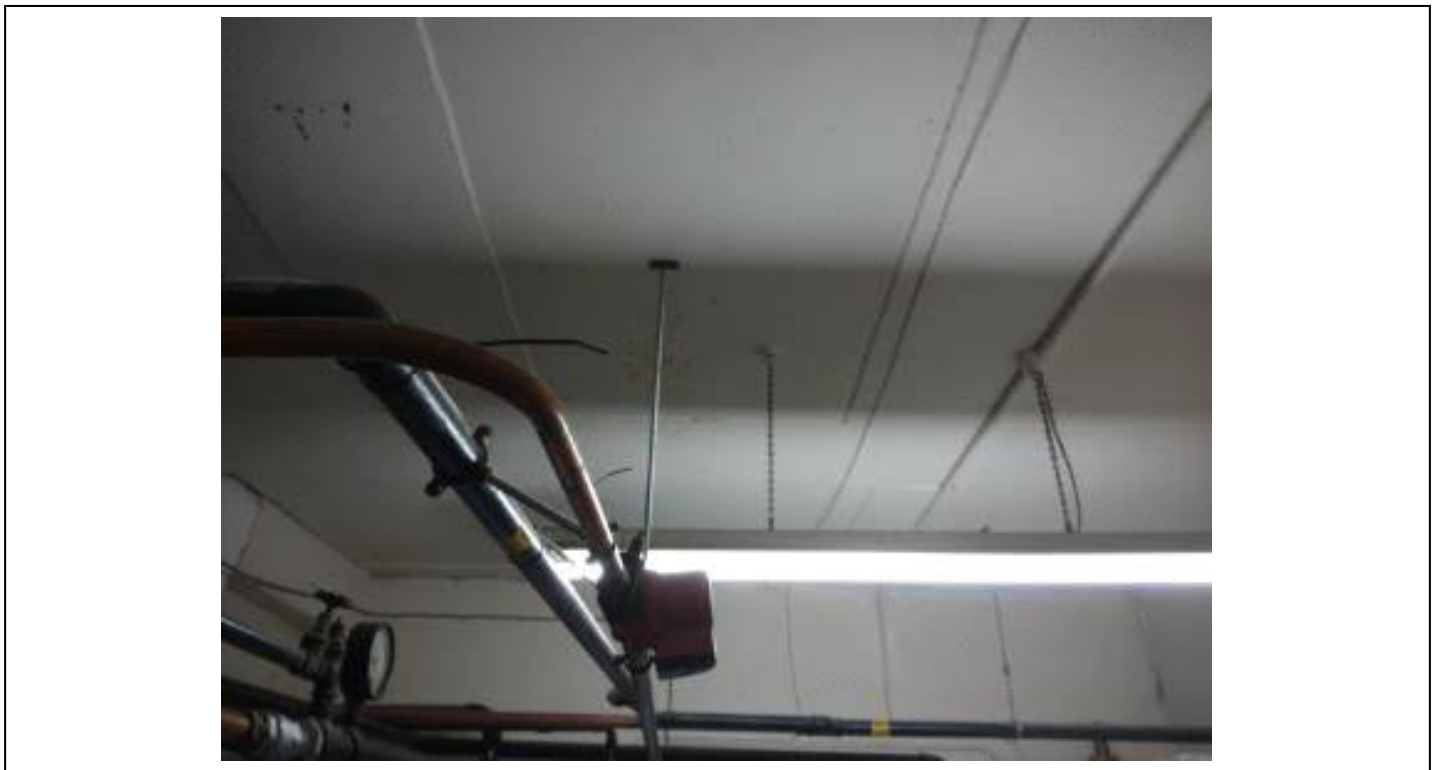
Item Number:	2 Ref Item: N/A	Sample Reference	AB000197
Item Description:	Ceiling panels	Approx. Quantity:	12m ²
Position:	Insulating board to ceiling	Identification:	Identified
Item Material:	Asbestos Insulating Board	Asbestos Present:	Amosite

MATERIAL ASSESSMENT (MA)		PRIORITY ASSESSMENT (PA)	
Product Type:	2	Maintenance Activity:	0
Damage:	0	Occupant Activity:	2
Treatment:	1	Likelihood of Disturbance:	2
Asbestos Type:	2	Human Exposure Potential:	3
MA Score:	5	PA Score:	7

Total Assessment:	12	Low	
Comments:			
Recommendation:	Manage & Monitor for Deterioration	Timescale	12 Months

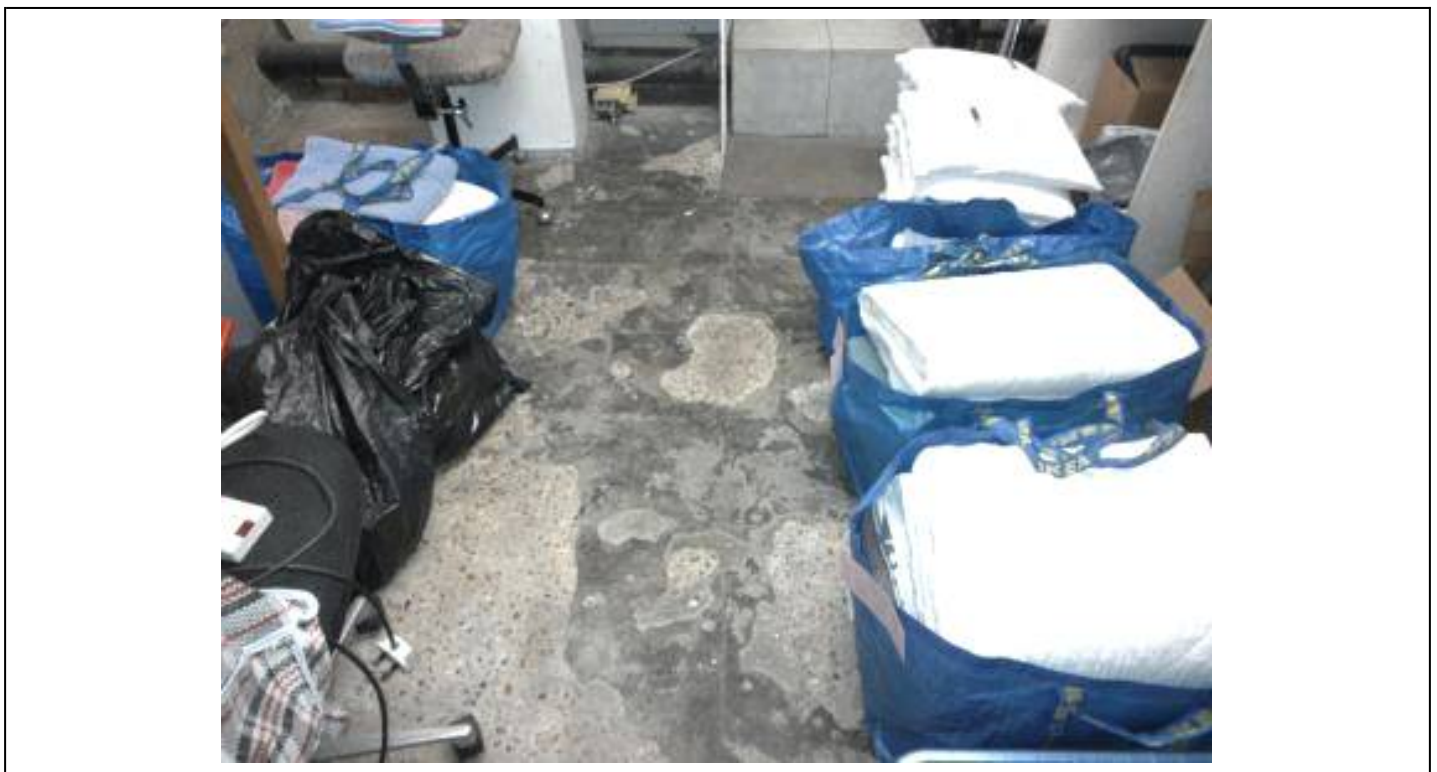
Item Number:	3 Ref Item: N/A	Sample Reference	AB000198
Item Description:	Screed	Approx. Quantity:	N/A
Position:	to concrete floor	Identification:	Identified
Item Material:	N/A	Asbestos Present:	No Asbestos Detected

Total Assessment:	N/A	N/A	
Comments:			
Recommendation:	No further action required	Timescale	N/A

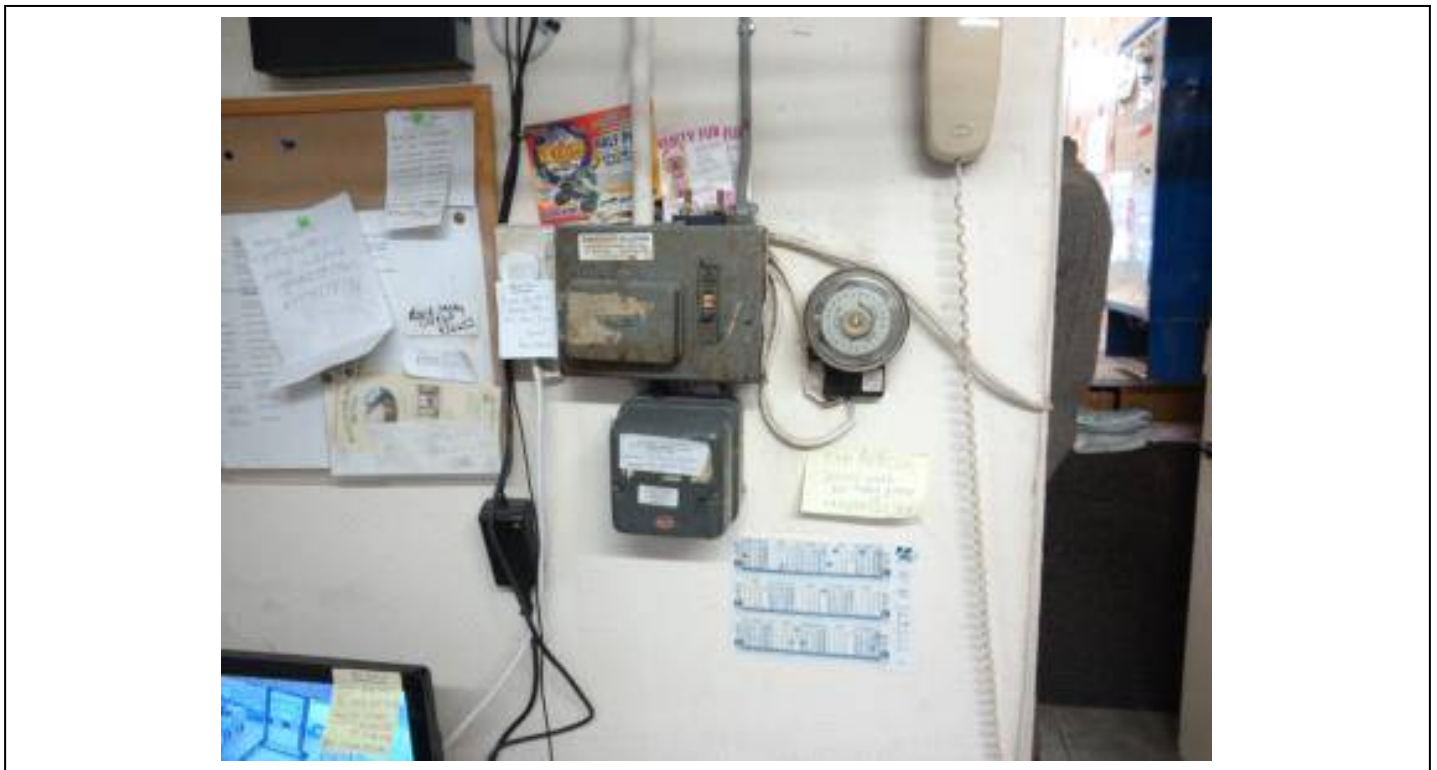
Item Number:	4 Ref Item: N/A	Sample Reference	Visual
Item Description:	Electrical plant	Approx. Quantity:	N/A
Position:	to wall	Identification:	Inaccessible (Presumed)
Item Material:	N/A	Asbestos Present:	N/A

Total Assessment:	N/A	N/A	
Comments:	Live		
Recommendation:	Inspect prior to Maintenance	Timescale	N/A

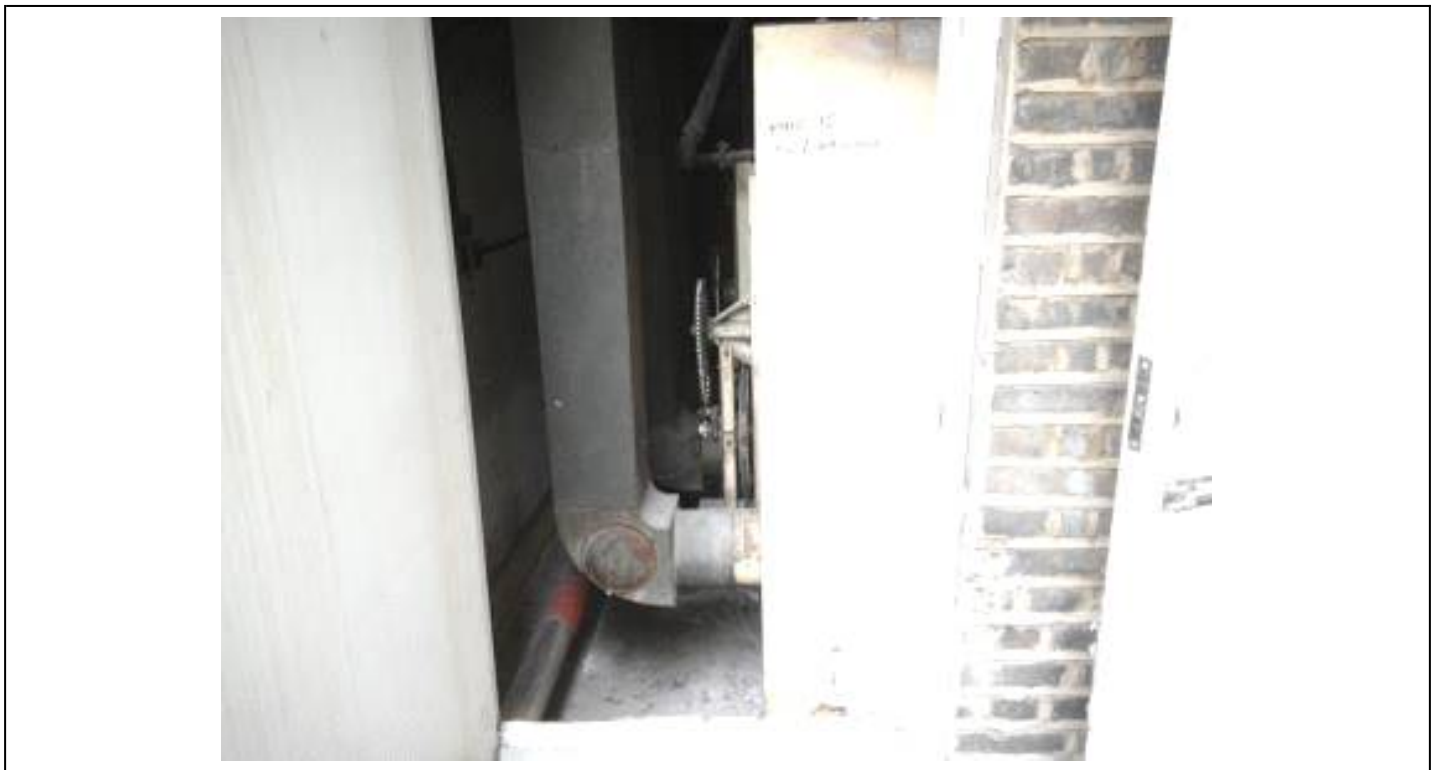
Item Number:	5 Ref Item: N/A	Sample Reference	Visual
Item Description:	Restricted access due to plant.	Approx. Quantity:	N/A
Position:	throughout	Identification:	Inaccessible (Presumed)
Item Material:	N/A	Asbestos Present:	N/A

Total Assessment:	N/A	N/A
Comments:	Restricted access, area obstructed by live plant.	
Recommendation:	Inspect prior to Maintenance	Timescale N/A

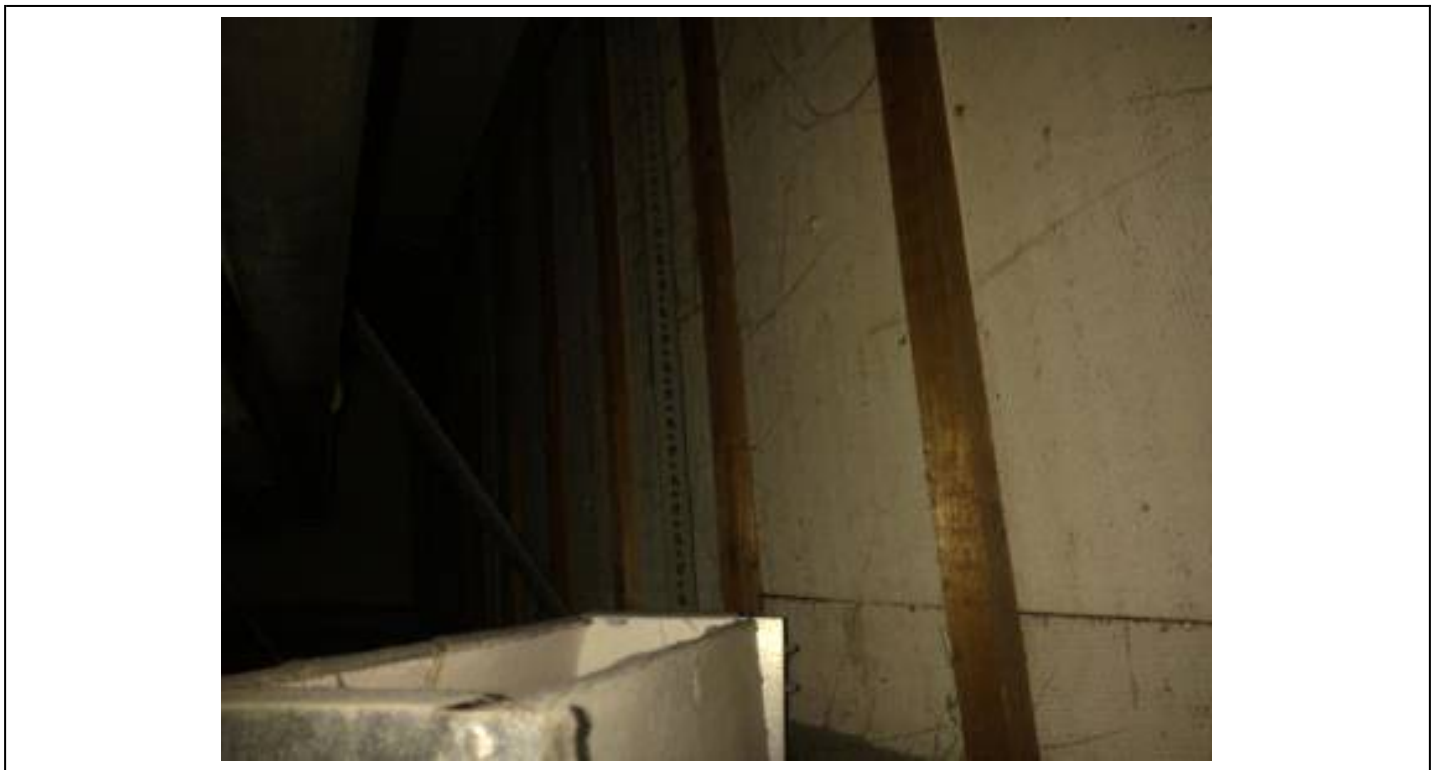
Item Number:	6 Ref Item: 1	Sample Reference	AS/ AB000196
Item Description:	Wall panels	Approx. Quantity:	See intern
Position:	Insulating board to walls	Identification:	Strongly Presumed
Item Material:	Asbestos Insulating Board	Asbestos Present:	Amosite

MATERIAL ASSESSMENT (MA)		PRIORITY ASSESSMENT (PA)	
Product Type:	2	Maintenance Activity:	0
Damage:	0	Occupant Activity:	0
Treatment:	2	Likelihood of Disturbance:	1
Asbestos Type:	2	Human Exposure Potential:	1
MA Score:	6	PA Score:	2

Total Assessment:	8	Low	
Comments:	See inspection 1		
Recommendation:	Manage & Monitor for Deterioration	Timescale	12 Months

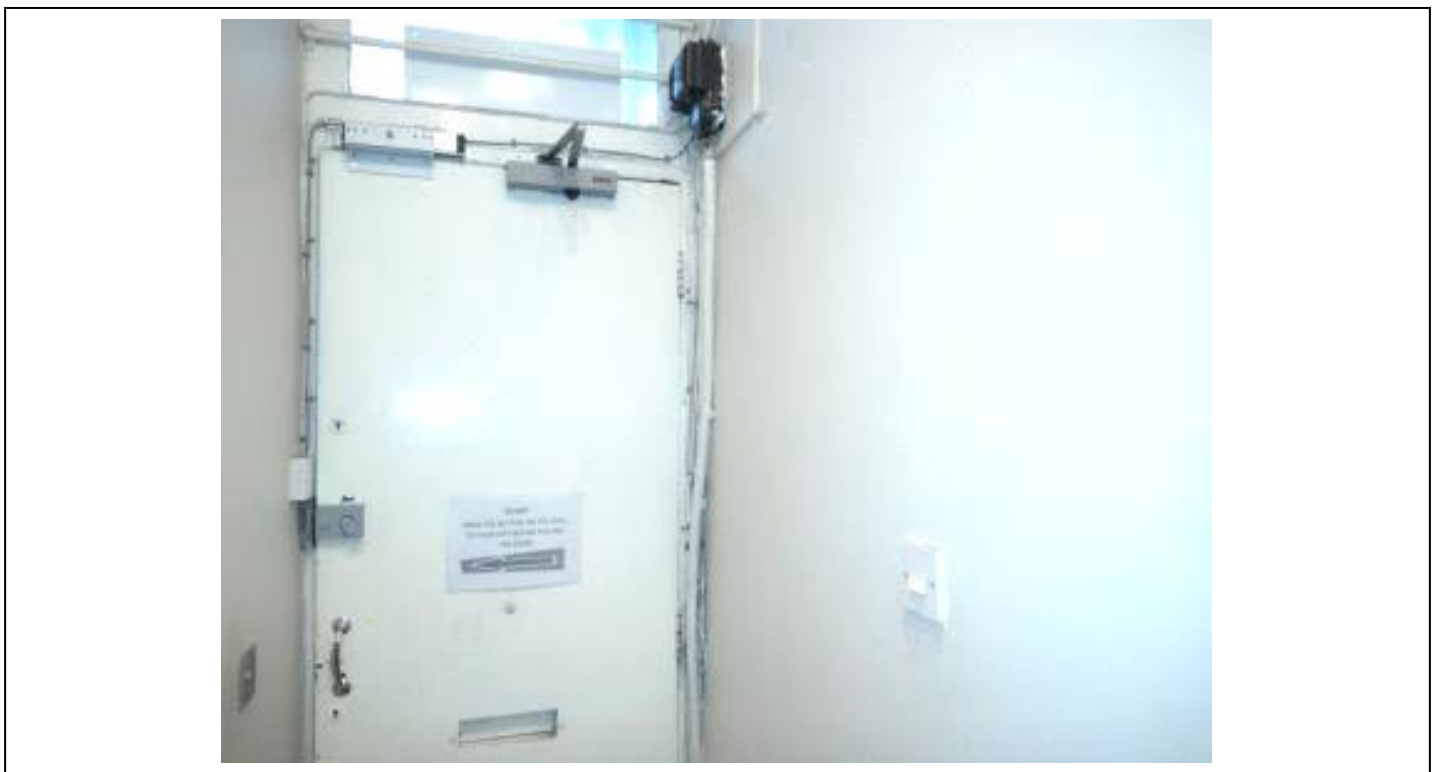
Item Number:	7 Ref Item: N/A	Sample Reference	Visual
Item Description:	Bitumen wrap	Approx. Quantity:	3lm
Position:	to mains intake	Identification:	Presumed
Item Material:	Asbestos Textiles/Paper	Asbestos Present:	Chrysotile

MATERIAL ASSESSMENT (MA)		PRIORITY ASSESSMENT (PA)	
Product Type:	2	Maintenance Activity:	0
Damage:	N/A	Occupant Activity:	0
Treatment:	1	Likelihood of Disturbance:	1
Asbestos Type:	1	Human Exposure Potential:	1
MA Score:	4	PA Score:	2

Total Assessment:	6	Very Low	
Comments:	Live		
Recommendation:	Manage & Monitor for Deterioration	Timescale	12 Months

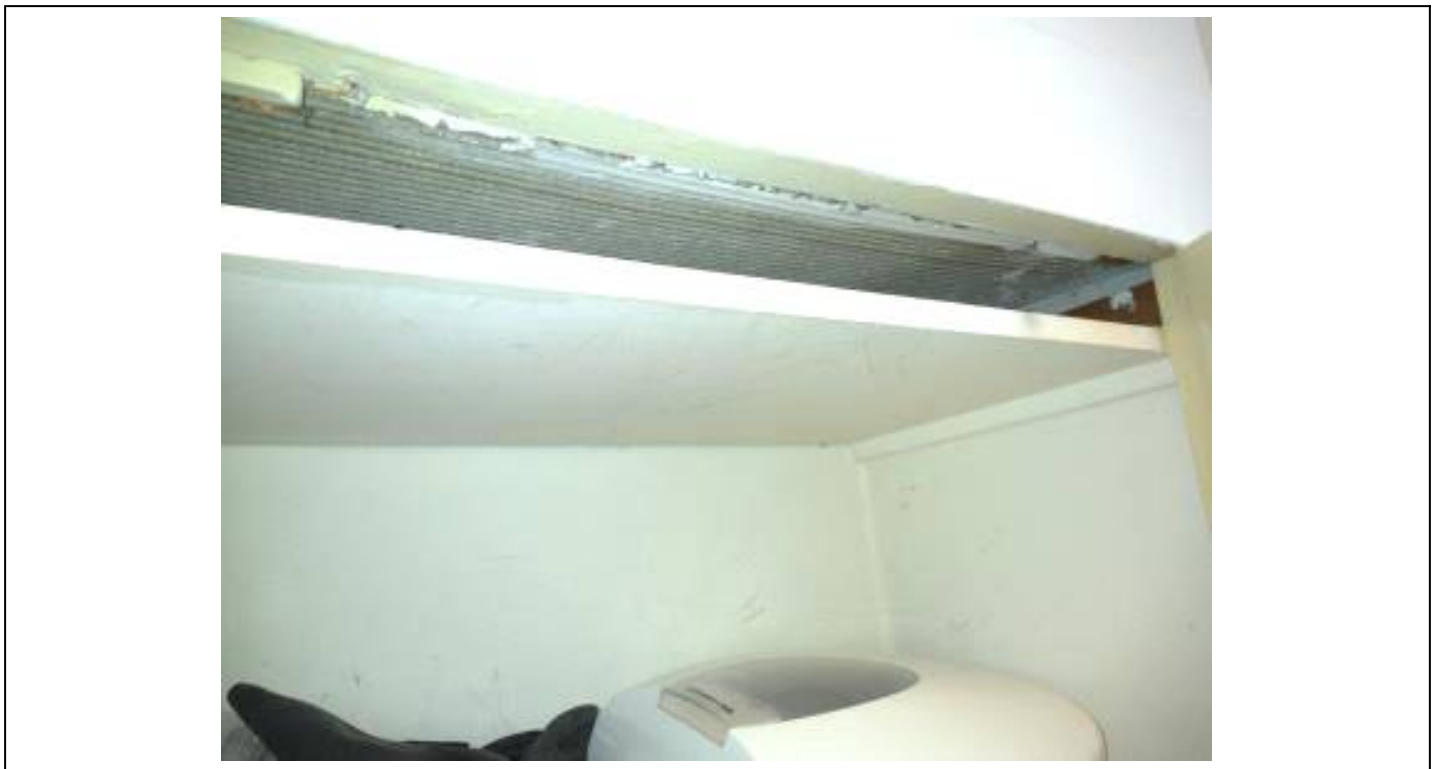
Item Number:	8 Ref Item: N/A	Sample Reference	AB000200
Item Description:	Cement soffit	Approx. Quantity:	0.25m ²
Position:	within cupboard [formerly the fire place].	Identification:	Identified
Item Material:	Asbestos Cement	Asbestos Present:	Chrysotile

MATERIAL ASSESSMENT (MA)		PRIORITY ASSESSMENT (PA)	
Product Type:	1	Maintenance Activity:	0
Damage:	1	Occupant Activity:	0
Treatment:	1	Likelihood of Disturbance:	2
Asbestos Type:	1	Human Exposure Potential:	1
MA Score:	4	PA Score:	3

Total Assessment:	7	Low	
Comments:			
Recommendation:	Manage & Monitor for Deterioration	Timescale	12 Months

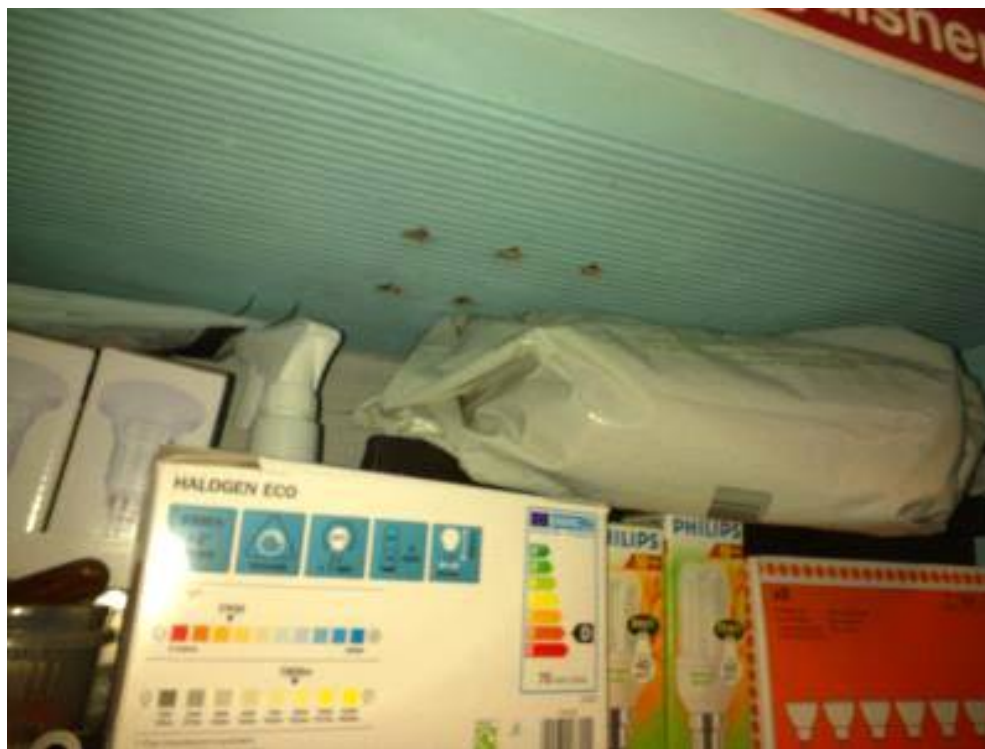
Item Number:	9 Ref Item: 8	Sample Reference	AS/ AB000200
Item Description:	Cement Soffit	Approx. Quantity:	0.25m ²
Position:	within cupboard [formerly the fire place].	Identification:	Strongly Presumed
Item Material:	Asbestos Cement	Asbestos Present:	Chrysotile

MATERIAL ASSESSMENT (MA)		PRIORITY ASSESSMENT (PA)	
Product Type:	1	Maintenance Activity:	0
Damage:	1	Occupant Activity:	0
Treatment:	1	Likelihood of Disturbance:	2
Asbestos Type:	1	Human Exposure Potential:	1
MA Score:	4	PA Score:	3

Total Assessment:	7	Low
Comments:	Sample not taken area occupied by staff	
Recommendation:	Manage & Monitor for Deterioration	Timescale: 12 Months

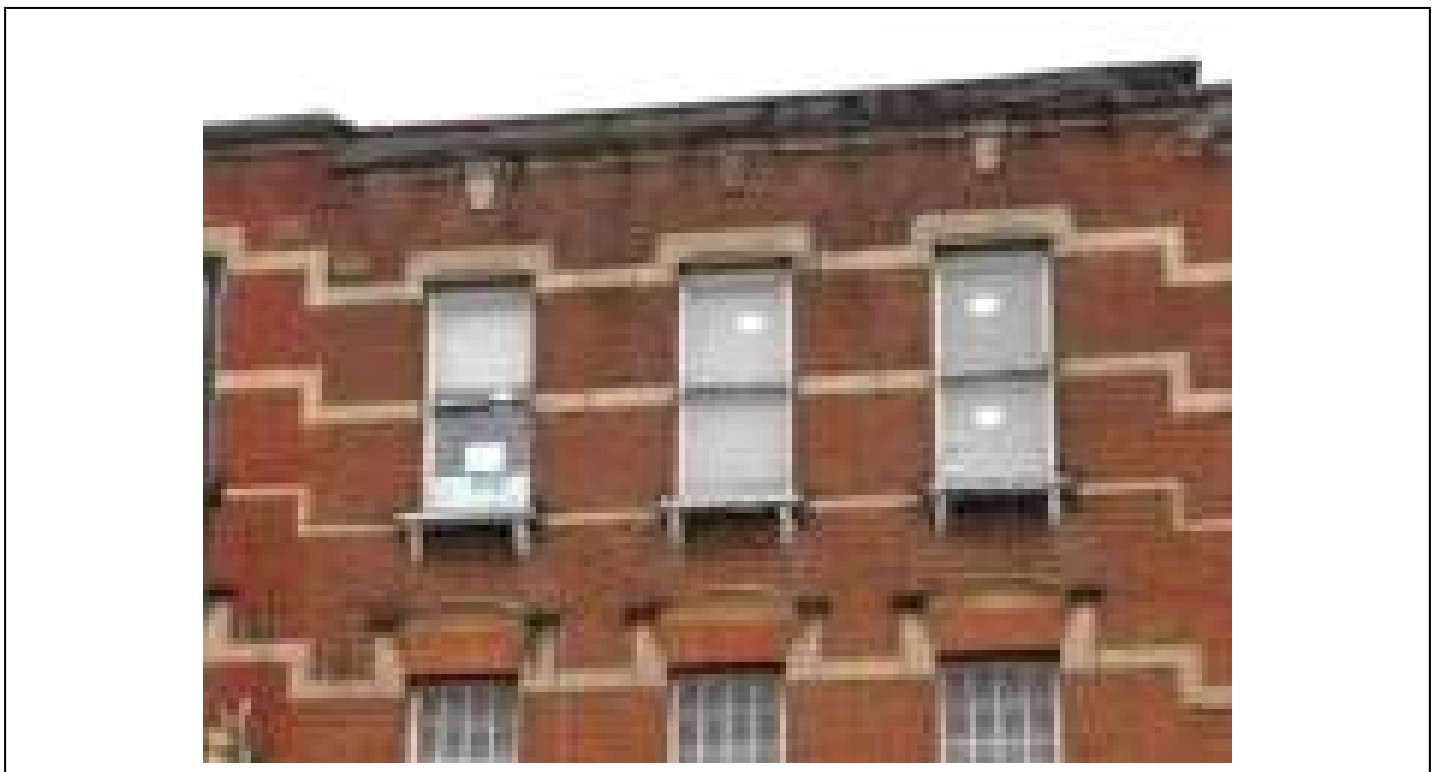
Item Number:	11 Ref Item: N/A	Sample Reference	Visual
Item Description:	Roof	Approx. Quantity:	N/A
Position:	Roof	Identification:	Inaccessible (Presumed)
Item Material:	N/A	Asbestos Present:	N/A

Total Assessment:	N/A	N/A	
Comments:	no safe access to roof.		
Recommendation:	Inspect prior to Maintenance	Timescale	N/A

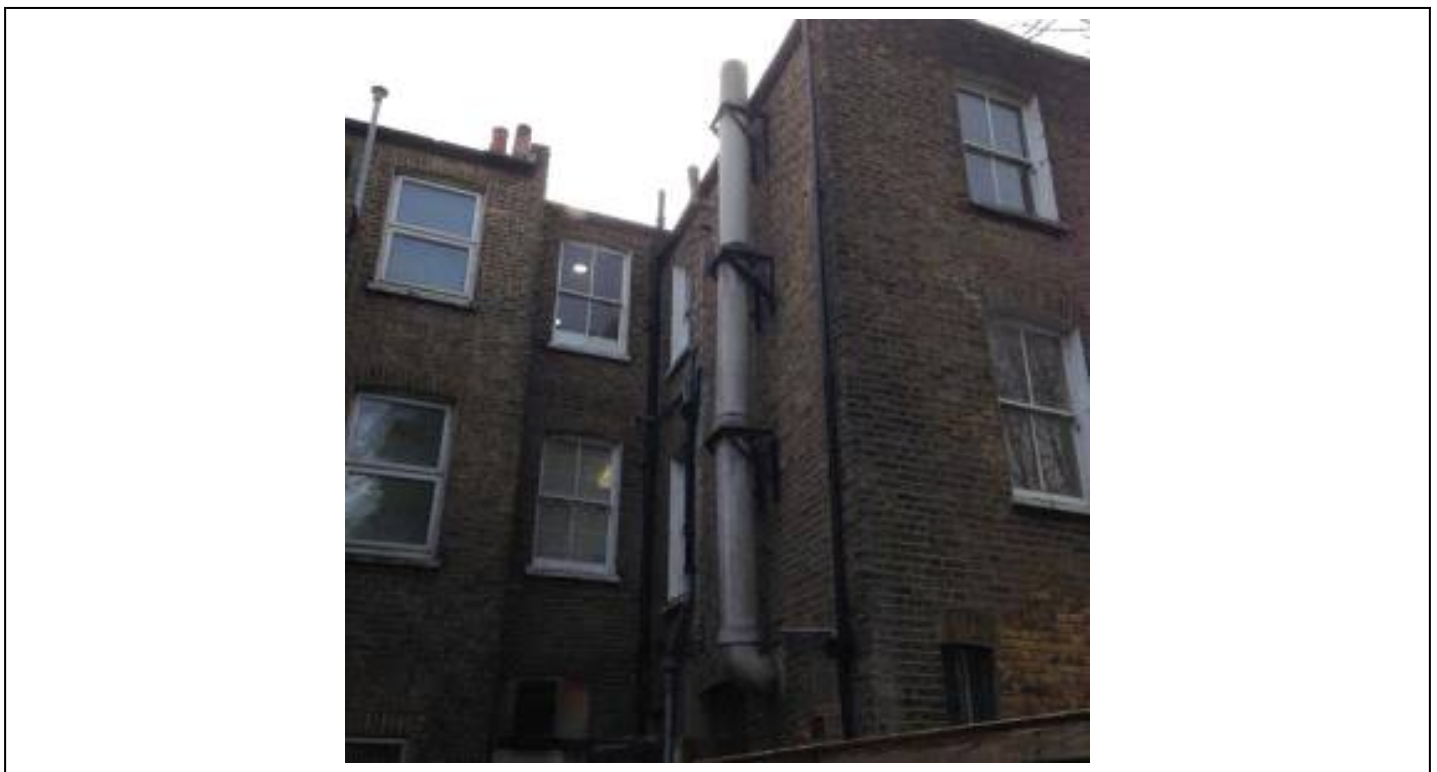
Item Number:	12 Ref Item: N/A	Sample Reference	AB000201
Item Description:	Cement duct	Approx. Quantity:	N/A
Position:	wall	Identification:	Identified
Item Material:	N/A	Asbestos Present:	No Asbestos Detected

Total Assessment:	N/A	N/A	
Comments:			
Recommendation:	No further action required	Timescale	N/A

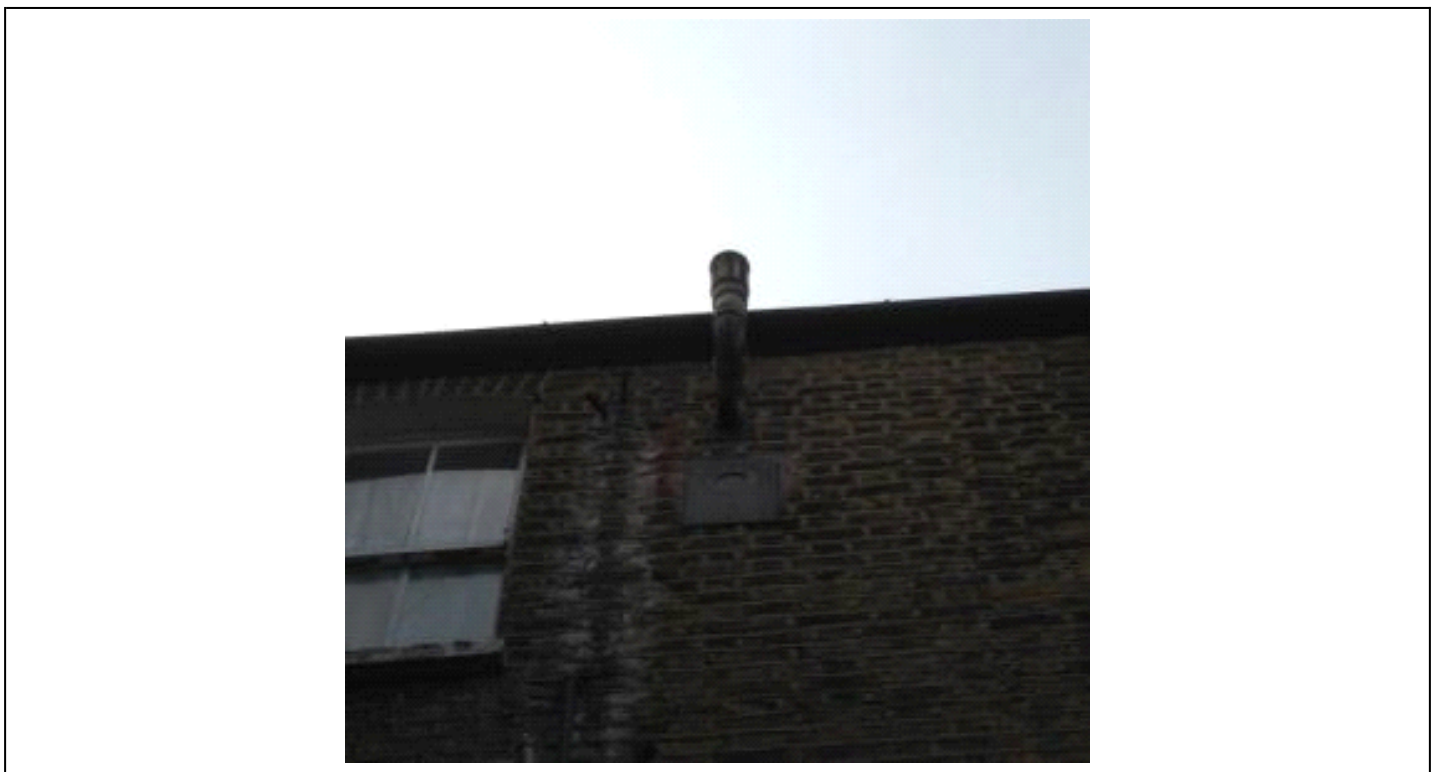
Item Number:	13 Ref Item: 12	Sample Reference	AS/ AB000201
Item Description:	Cement flue and cowl	Approx. Quantity:	N/A
Position:	wall	Identification:	Strongly Presumed
Item Material:	N/A	Asbestos Present:	No Asbestos Detected

Total Assessment:	N/A	N/A	
Comments:			
Recommendation:	No further action required	Timescale	N/A

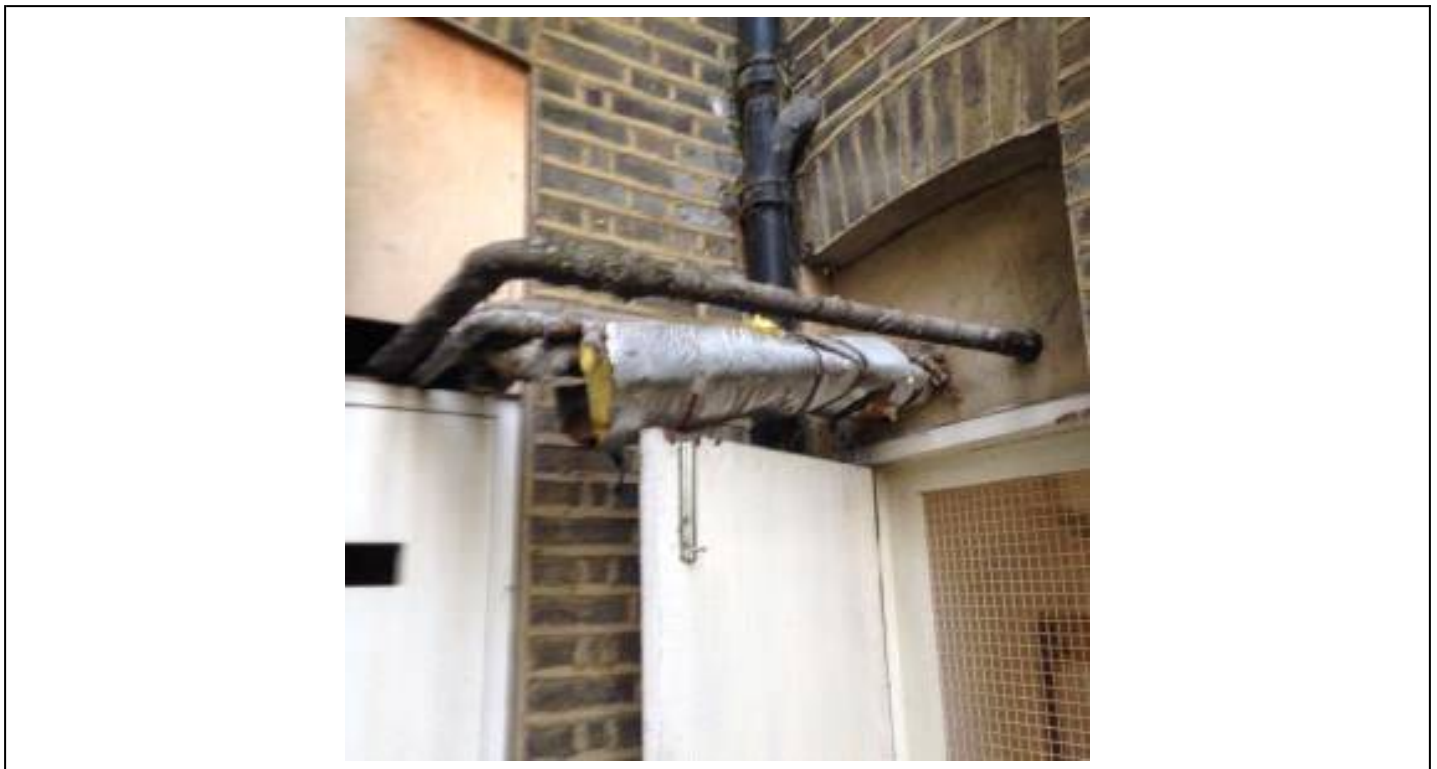
Item Number:	14 Ref Item: N/A	Sample Reference	AB000202
Item Description:	Bitumen wrap	Approx. Quantity:	N/A
Position:	to gas pipe leading into plant room.	Identification:	Identified
Item Material:	N/A	Asbestos Present:	No Asbestos Detected

Total Assessment:	N/A	N/A	
Comments:			
Recommendation:	No further action required	Timescale	N/A
